Manhole Inspection Summary

Manhole # S06GG2011MH

Insp Date: **8/11/06 10:49 AM**

Location Address: **7037 WALLIS AVE**

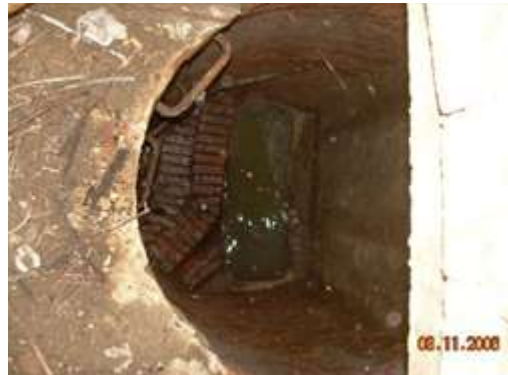
Top View

Corbel and Barrel infiltration. Corroded steps.

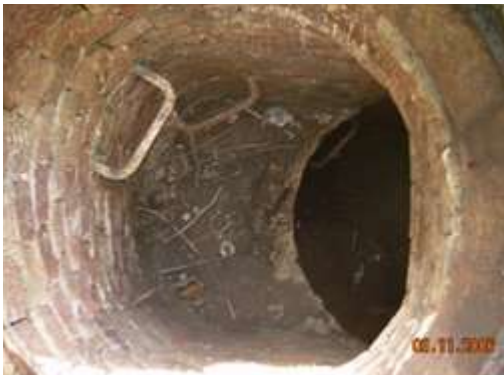
Top View

Frame leaks. Adjustment loose brick.
Adjustment infiltration.

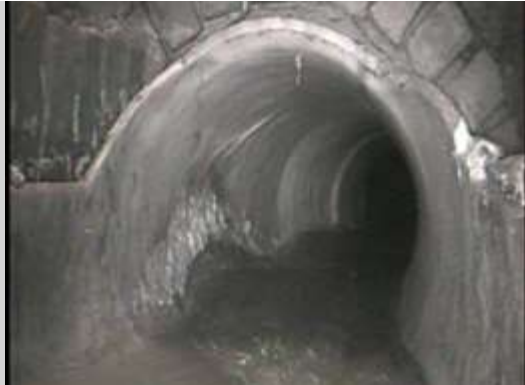
18 in. Circular Gravity Sewer Pipe Out @ 12 O'Clock

Comments **The O12 pipe liner appeared to be start to deteriorating.**

pipe liner appeared to be start to deteriorating.

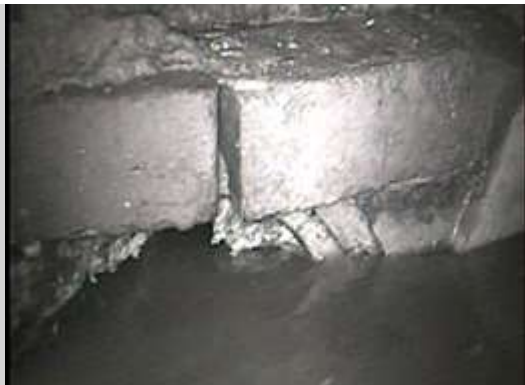
12 in. Circular Gravity Sewer Pipe In @ 3 O'Clock

pipe is almost sub-merged of sewer in main channel
